**ANNE ARUNDEL COUNTY**  
**OFFICE OF THE FIRE MARSHAL**  
**FIRE & EXPLOSIVES INVESTIGATION UNIT**

**MACRO TIMELINE**

**FIB CASE #: 25-056**

**INCIDENT DATE: 04/13/2025**

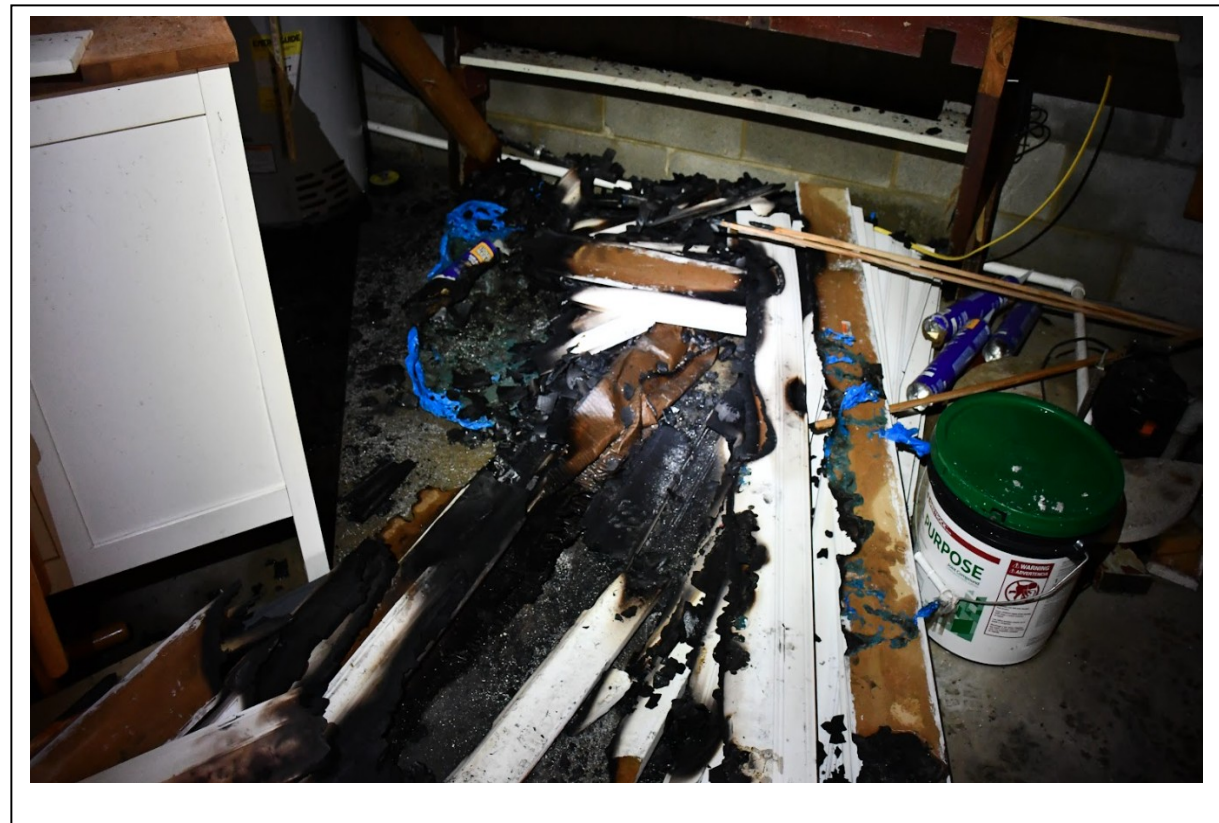
1. Below was a fire located in the basement of the residence on the B/C side, just under the electrical panel of the home, immediately in front of the sliding door:

The following hypotheses as to how this fire occurred were considered and ruled out:

**Electrical fire:** I considered this theory as to the cause of this fire and was able to rule this theory out. This fire origin was in close proximity to the electrical panel, but there was not extension to or from the electrical panel. There was no evidence of any electrical issues in the panel itself and the panel was in working condition with no fire damage. The debris

itself was searched through and there was no evidence of any sort of electrical or battery source.

**Smoking fire:** Discarded cigarettes, marijuana, or other smoking materials were considered for this fire event and I was able to rule out this theory.

**Spontaneous combustion:** I considered this theory and was able to rule out spontaneous combustion as a possibility for the fire activity for this event. There was no materials or chemicals within the area that would be consistent with that of a spontaneous combustion.

**Intentionally set fire:** After considering every possibly ignition source, the only ignition source that was competent to start this fire was an external source such as a cigarette lighter or matches. This fire was started by the intentional act of a human and this was the only remaining hypothesis after considering every other way that this fire could have been created.

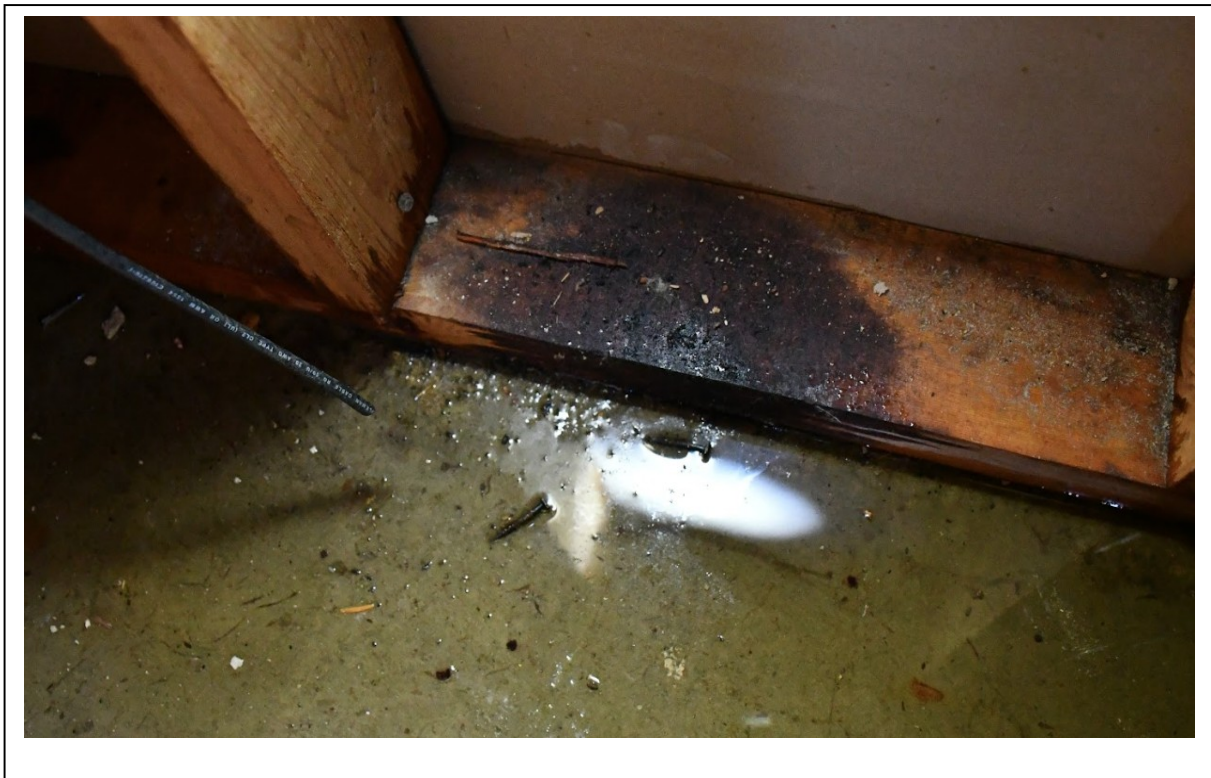
2. Shown below are the damages of a fire in the basement on the B/C side room against the far left wall, which would be represented as the D side wall:

This fire had no reasonable fuel load that suffered any significant fire damage nor was there any sort of ignition source anywhere within the immediate vicinity. The fire was to structural wooden beams of the home and could be described as charring. There may have been a combustible material that sat on top of the wood that had been consumed by the fire or an open flame was held to wood itself.

The following hypotheses as to how this fire occurred were considered and ruled out:

**Electrical fire:** This theory was considered but was ruled out as there was no electrical sources anywhere within the vicinity of this fire activity that could have been an ignition source or cause for this fire.

**Embers:** I considered an ember or firefighter suppression activity being responsible for this distinctive burn into the wood and was able to rule that out. The larger basement fire that is photographed under “1,” could not have communicated with this fire. There were physical barriers between these fires which would have eliminated any possibility of an ember traveling to this location and being the ignition source for a separate fire. Additionally, the distance from this fire and the larger fire titled “1” was too far for either of these fires to be responsible for the cause of the other fire.

**Intentionally set fire:** This fire was an independent fire from every other fire activity in the house. The cause of the fire was the intentional introduction of an external ignition source such as a cigarette lighter or matches. The fuel was either a completely consumed combustible or the open flame was held to the wood itself.

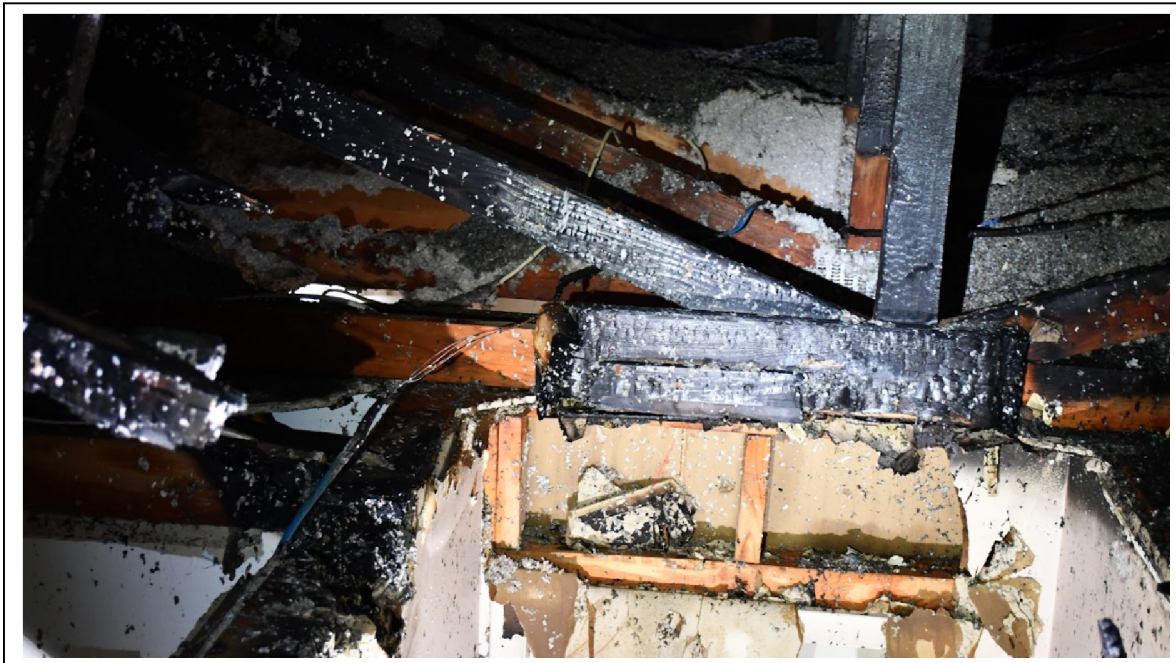
3. Below is a photograph of the attachment point for the foldable attic ladder:

In terms of fire spread and intensity, fuel consumption, and overall damage to the structure, the fire in the attic was the most significant fire event associated with the home of 3 Belhaven Court. The fire spread through a large portion of the attic and partially and completely consumed numerous structural support beams for the roof itself.

There were numerous rags found draped over the wooden beams in the attic, which I was able to conclude were not there the day prior when the electrician was in the attic. The rags were laid out in a manner that was consistent with an individual attempting to use them as a continuous fuel source. The ignition temperature for 2x2 and 2x4's would be too high for somebody to realistically hold a lighter to in order to start a fire. The rags have a much lower ignition temperature and were utilized to act as the first fuel ignited, which then in turn ignited the wooden beams. The timeline, which is detailed in this report under "Timeline" is consistent with a slow burning fire in the attic space of this home with the fuel package that I know was in the space.

The following hypotheses as to how this fire occurred were considered:

**Electrical fire:** There was wiring that ran through the attic so an electrical fire was considered. I was able to rule this out through my own examination of the wires and determined that the fire damage to the wiring itself was minimal and a result of heat damage from the fire, not a cause of the fire. Additionally, Travelers Insurance performed

an additional origin and cause examination that consisted of a fire investigator along with an engineer. I accompanied the private investigators on their investigation at 3 Belhaven Court and the engineer was able to conclude on scene that the wires in the attic were not a cause of this fire. While this was only a verbal confirmation Travelers collected the wires as evidence to perform testing to confirm the on-scene findings. This evidence and any report associated with it will be provided to the States Attorney once I receive it.

**Intentionally set fire:** After considering all possible ignition sources for the attic fire, the only ignition source that was competent enough to be responsible for this activity was an external ignition source such as a cigarette lighter or matches. The fuel for this fire may have been combustibles that were consumed by the fire or they were the readily available combustibles within the attic, which would just be the actual structure itself. There was no storage in the attic at the time of this event.

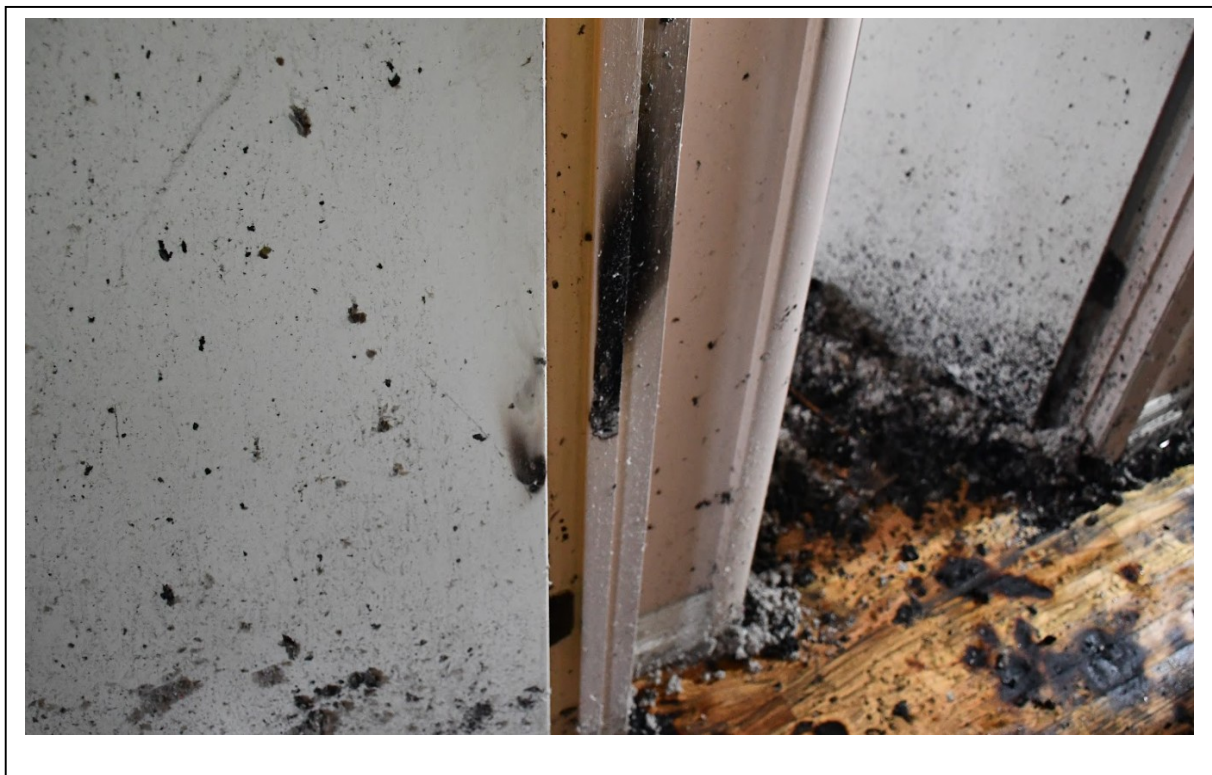
4. Below is a fire that occurred between the door jam on the first level of the home in the A/B side bedroom:

The following hypotheses as to how this fire occurred were considered:

**Drop-down debris:** The attic fire was located directly above this door-jam. I considered the possibility of fire burning through the attic floor or fire suppression efforts from the fire department causing debris to drop down, which in turn would cause this fire. I was able to rule this out after determining that it was not possible. The charring in this door-jam could only have occurred if there was a sustained flame to the wood itself. This area of the door-jam had no ledge or lip that would allow drop-down to settle and for the fire to grow.

**Intentionally set fire:** The only hypothesis for this fire that remained after considering all possible ignition sources was that a human used an external ignition source such as a cigarette lighter or matches. There may have been a combustible lodged between the door that was consumed by the fire or the human held a lighter or match to the specific area between the doorjam long enough for a fire to occur.

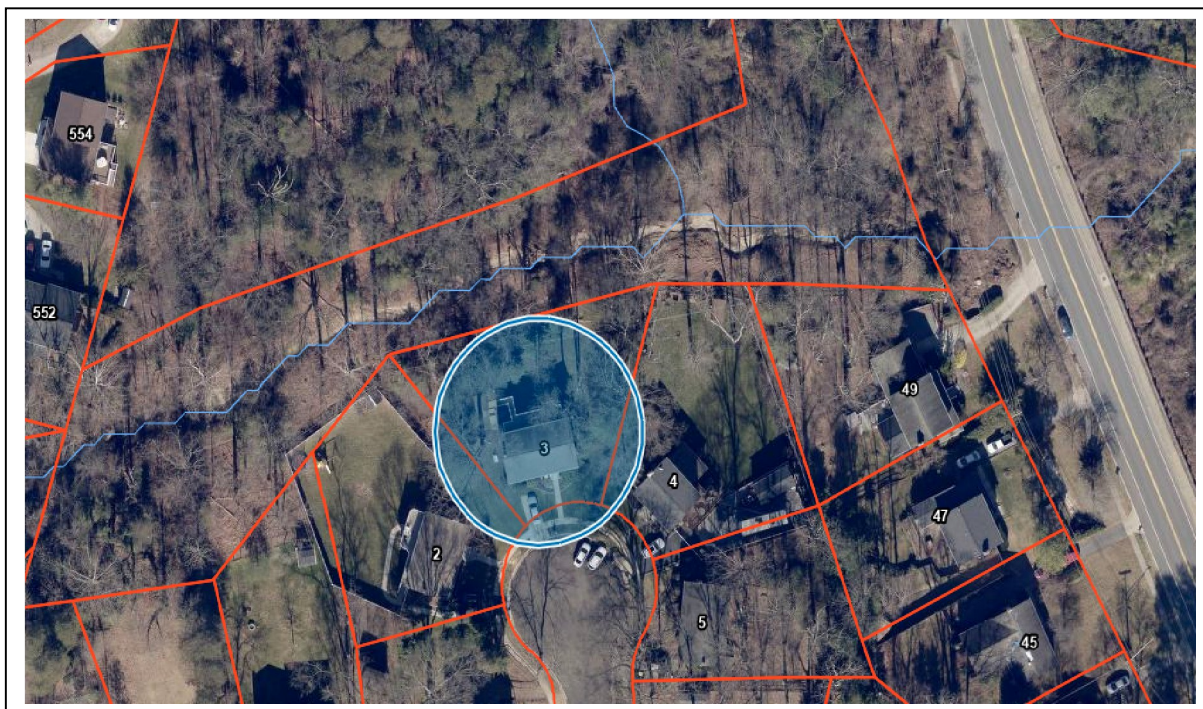
There were access points on the rear of the dwelling which would be represented as the C side. I was able to conclusively ascertain Aaron Keel entered the dwelling through the C side by traveling through the woods that is directly behind 3 Belhaven Court.

The photograph on the previous page shows the uniqueness to the positioning of 3 Belhaven Court. The only logical access point would be from the street side of the court. Mr. Keel's unique knowledge of the home itself and surrounding areas is responsible for him utilizing an unconventional path in order to access the home.

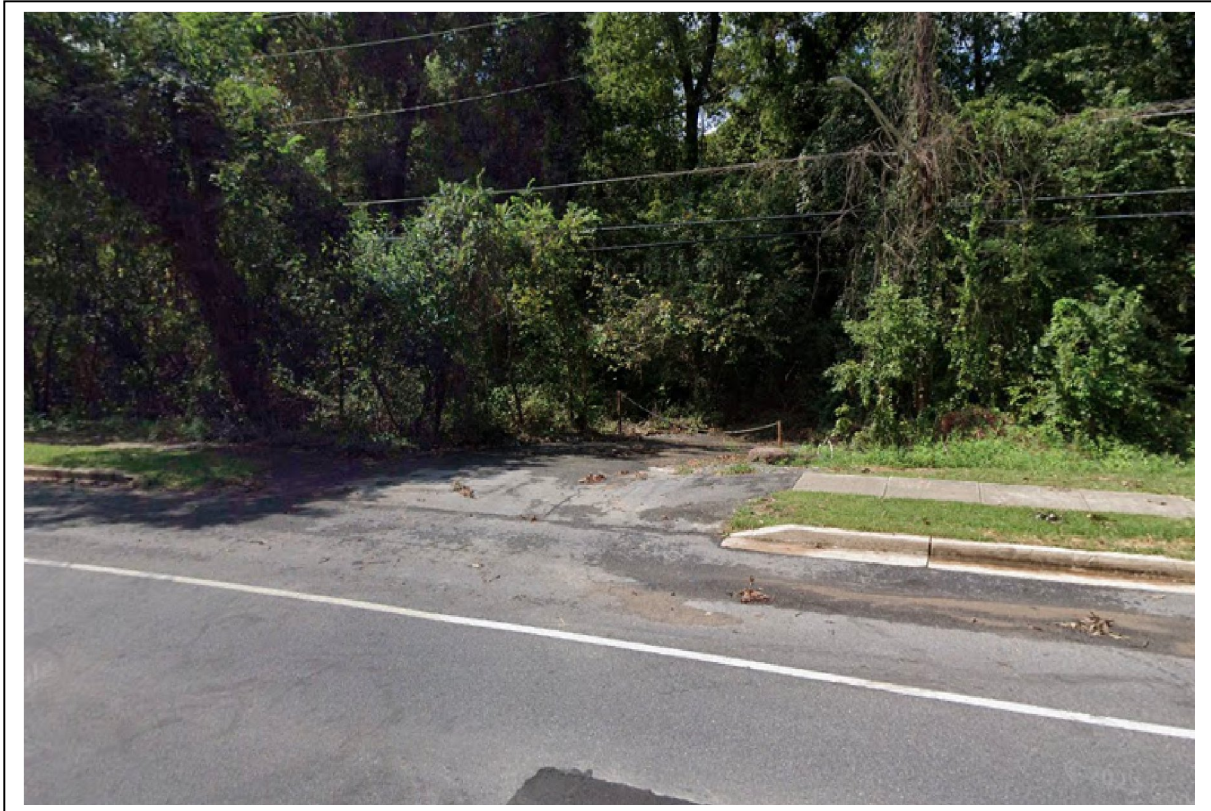
- 1. 02:21am** – (Exits residence – 91 Eastway): Aaron Keel drives from his home on Eastway towards the direction of Northway.
- 2. 02:22am** – (Port-Potty 1 – Oak Hill Elementary): Aaron Keel turns left onto Truck House Road coming from Northway. This is towards the direction where he ultimately parks.
- 3. 02:22am** – (Driveway – 102 Truck House): Aaron Keel drives past the area where he will ultimately park on Truck House Road.
- 4. 02:23am** – (Driveway – 102 Truck House): Aaron Keel drives back towards the direction of Severndale neighborhood on Truck House Road. He parks on the side of the road next to a "cut-through" in the woods that is parallel to 3 Belhaven Court. The cut-through that he parks in front of can be referenced in the below photograph:

5. **02:24am** – (Driveway – 102 Truck House): Aaron Keel turns his vehicle lights off and turns his flashers on while parked in front of the cut-through. He then steps out from the driver side of his vehicle and grabs an unknown object out of his car. He walks into the woods for a few seconds before reappearing. He then gets back in his vehicle and departs the area. He drives on Truck House Road towards the direction of Oak Hill Elementary School.

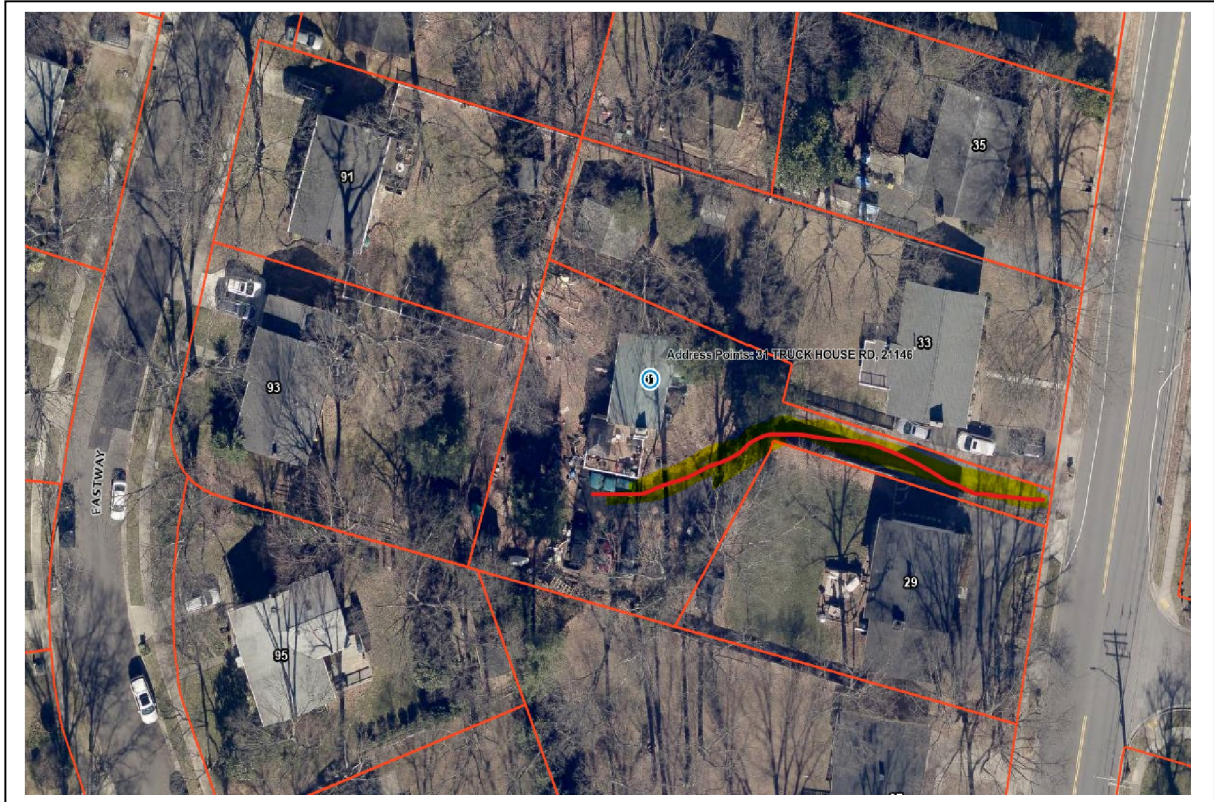
**11.02:31am** – (Leaving – 31 Truck House Road): Aaron Keel’s home is referenced in the above picture compared to that of 31 Truck House Road. His home has “93” in the center of it while 31 Truck House has a small circle. Aaron had to maneuver a fence in order to walk through this property. The highlighted area is the driveway that belongs to 31 Truck House Road. Aaron walked towards the direction of the driveway, which leads to Truck House Road. This is also the same area that Aaron drove towards when departing the school prior to turning around and driving back into the Severndale neighborhood.

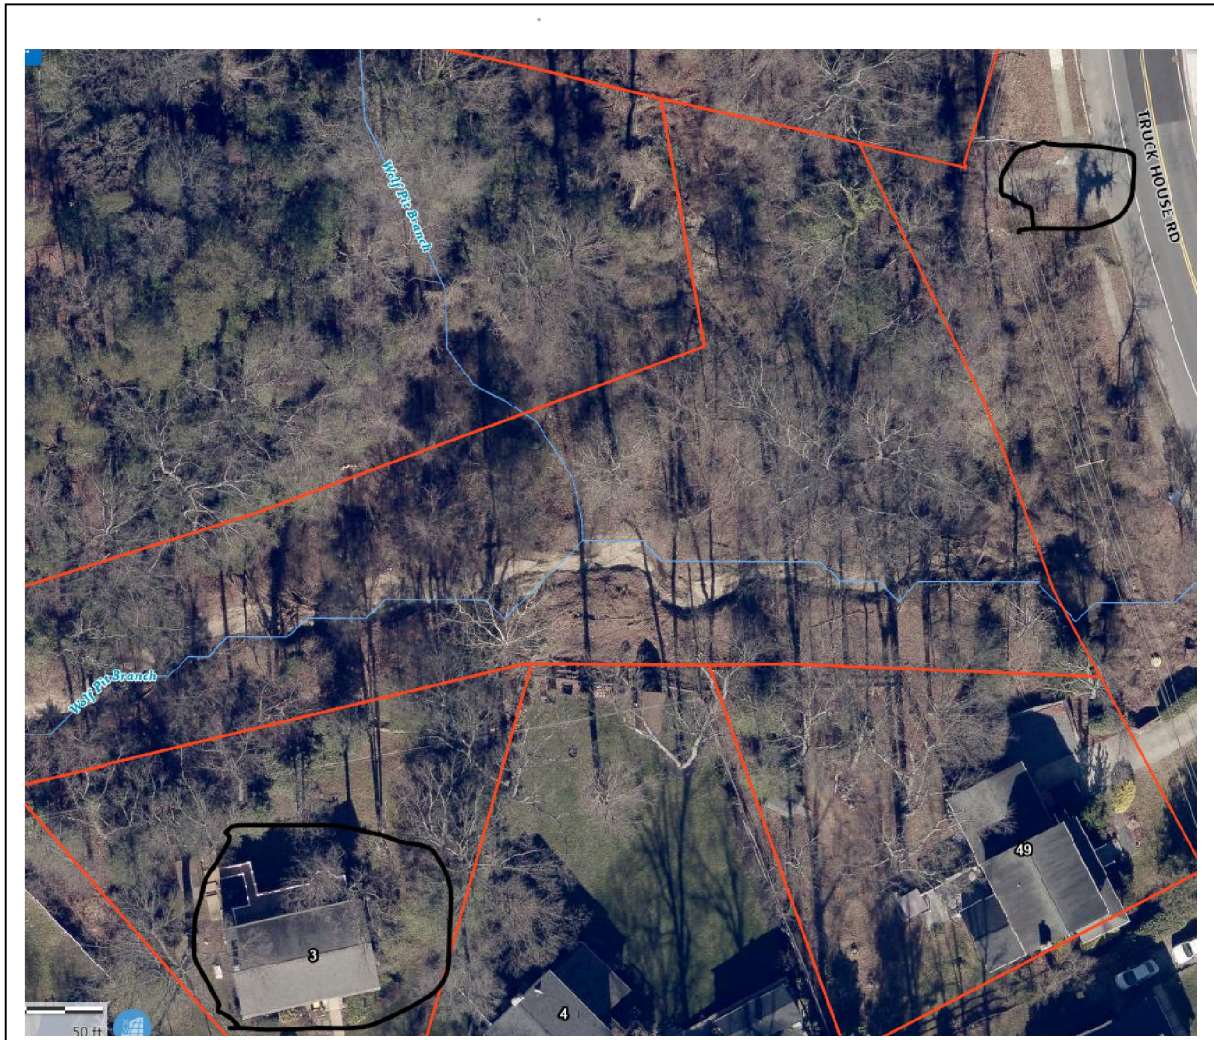
**14. 02:37am** – (Driveway – 102 Truck House Road): Aaron Keel walks into the woods at the exact location that he was parked at 02:24, thirteen minutes prior. Below is a reference point to where the cut-through in the woods is located compared to the residence at 3 Belhaven Court:

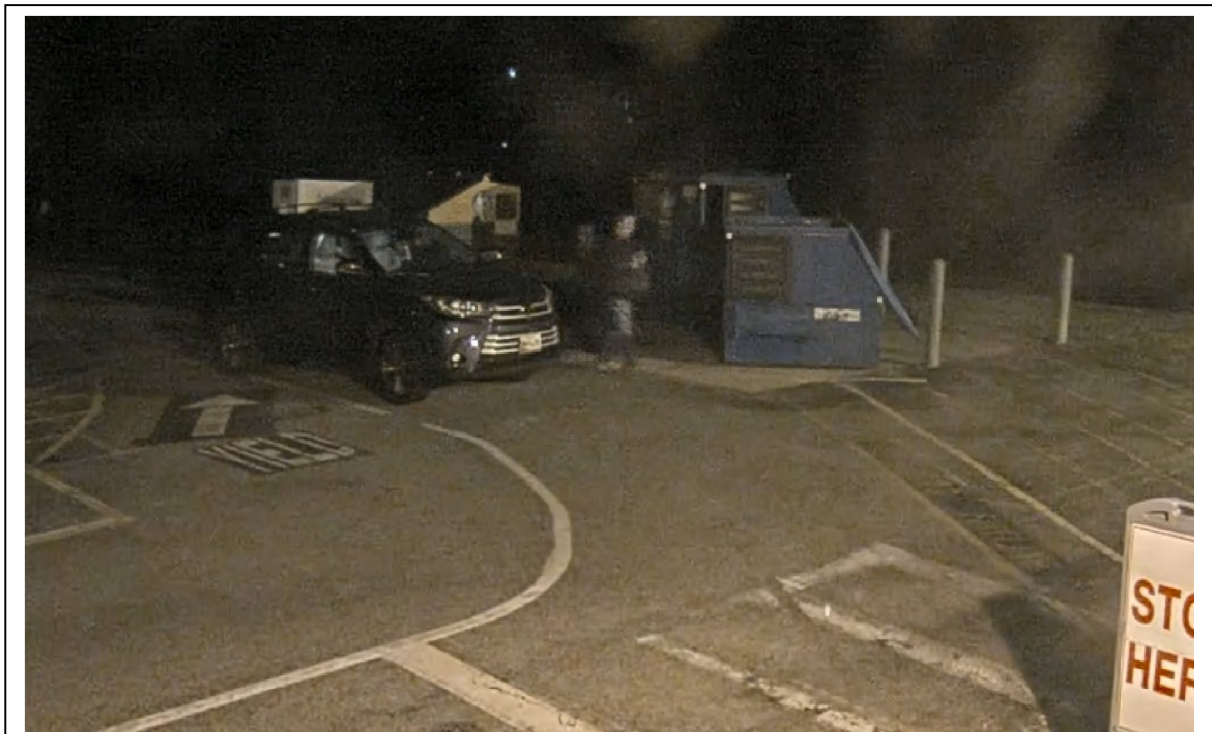
At this point in my investigation, I did not have any viable identification as to who the suspect was. On the evening of April 24, 2025, I drove to the Johnson's residence located at 4 Belhaven Court, Severna Park, MD 21146. I showed them a still-shot and the video from the elementary school, which is labelled "Dumpsters 1."

Below is a still-shot from that video that I showed both Stefanie and Matthew Johnson

After giving Stefanie and Matthew Johnson the opportunity to review this footage and photographs associate with it, they both identified the suspect with 100% certainty as Mr. Aaron Keel
